## Phase I - Environmental Site Assessment

Proposed Cardinal Creek Village Subdivision Lands  
Old Montreal Road  
Ottawa (Cumberland), Ontario

November 7, 2012

Report: PE2392-2

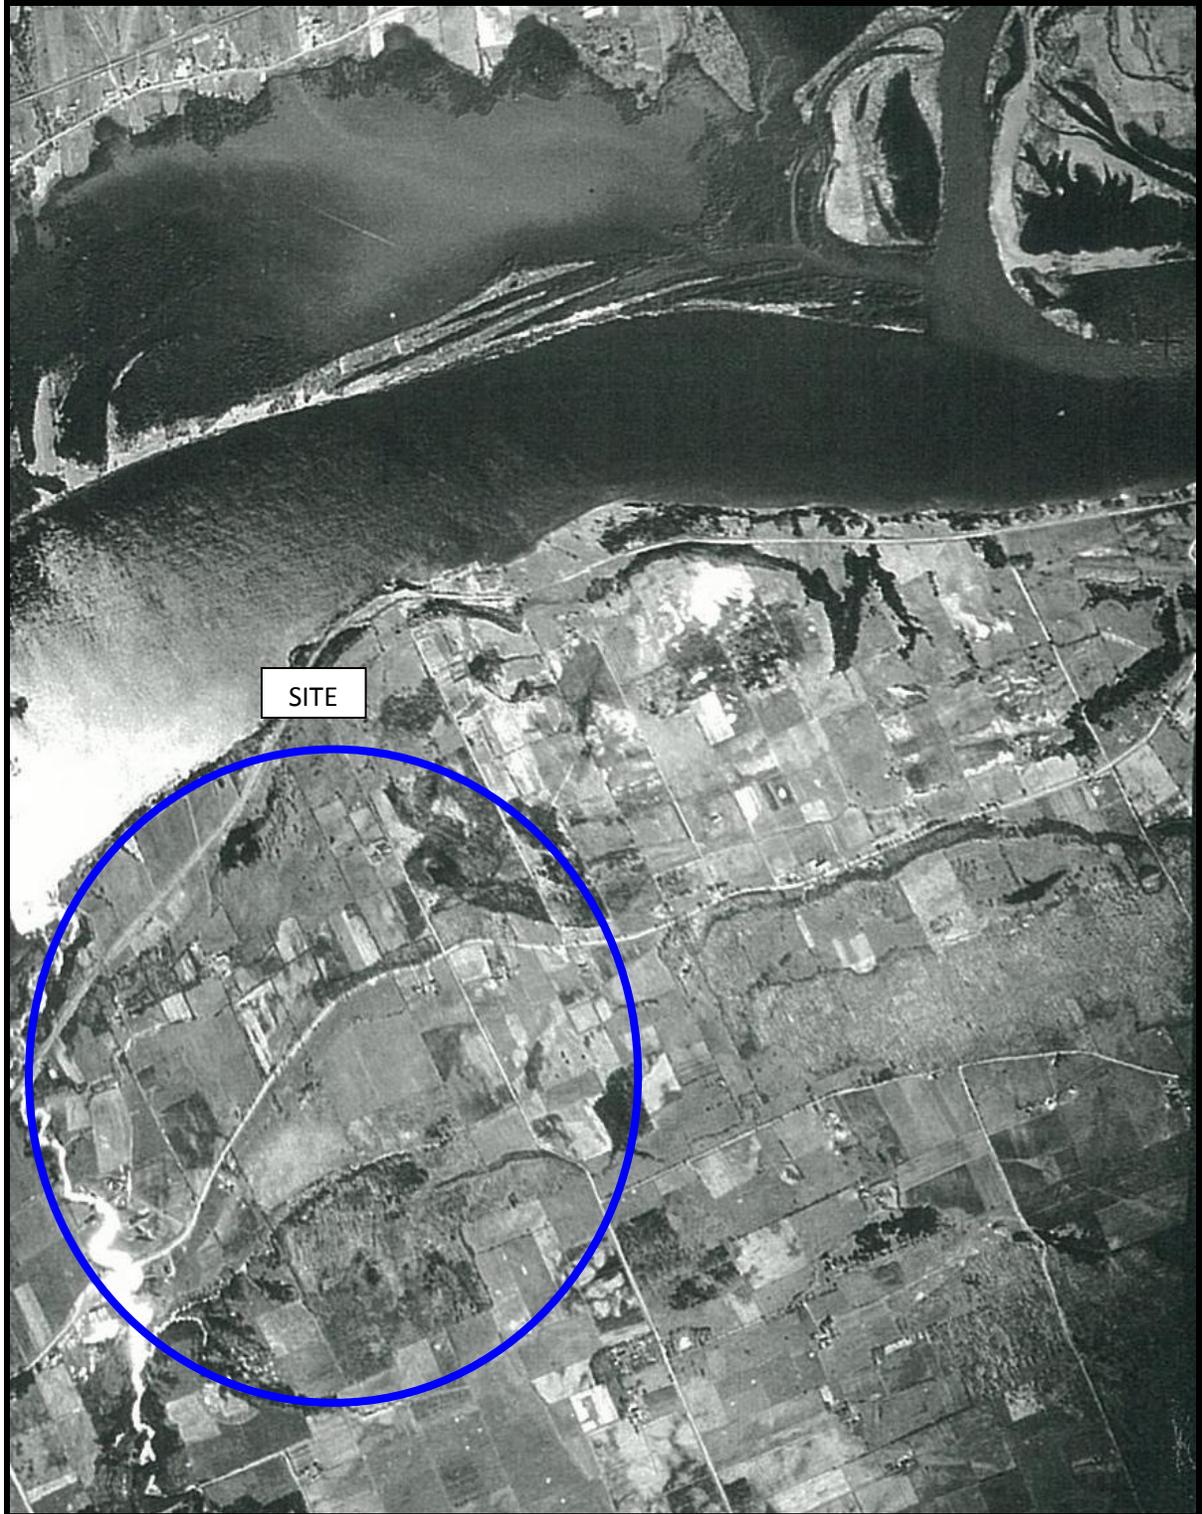
AERIAL PHOTOGRAPH  
1949

1949      The subject site and adjacent properties are vacant cleared land and appear to be used for agricultural purposes. What appears to be a railway line transects the northern portion of the subject site in an approximate east-west direction. Cardinal Creek borders the property to the west, however a portion of the creek transects the northwestern portion of the site in an approximate northeast-southwest direction. Rural residences are present along the south side of Old Montreal Road, while the existing farmstead is present at 1291 Old Montreal Road, north of Old Montreal Road on the central portion of the subject site. Building structures appear to be present just east of Cardinal Creek, also north of Old Montreal Road. The area to the south of the creek and ravine, located on the southern portion of the site, is wooded.

The property is bordered to the north by Regional Road 174 followed by vacant land and the Ottawa River. Vacant land with a possible farmstead followed by Ted Kelly Lane and Frank Kenny Road are present to the east of the site, with Cardinal Creek to the west. Further east and west are agricultural lands or wooded areas. Agricultural fields and wooded areas are also present to the south of the subject property.

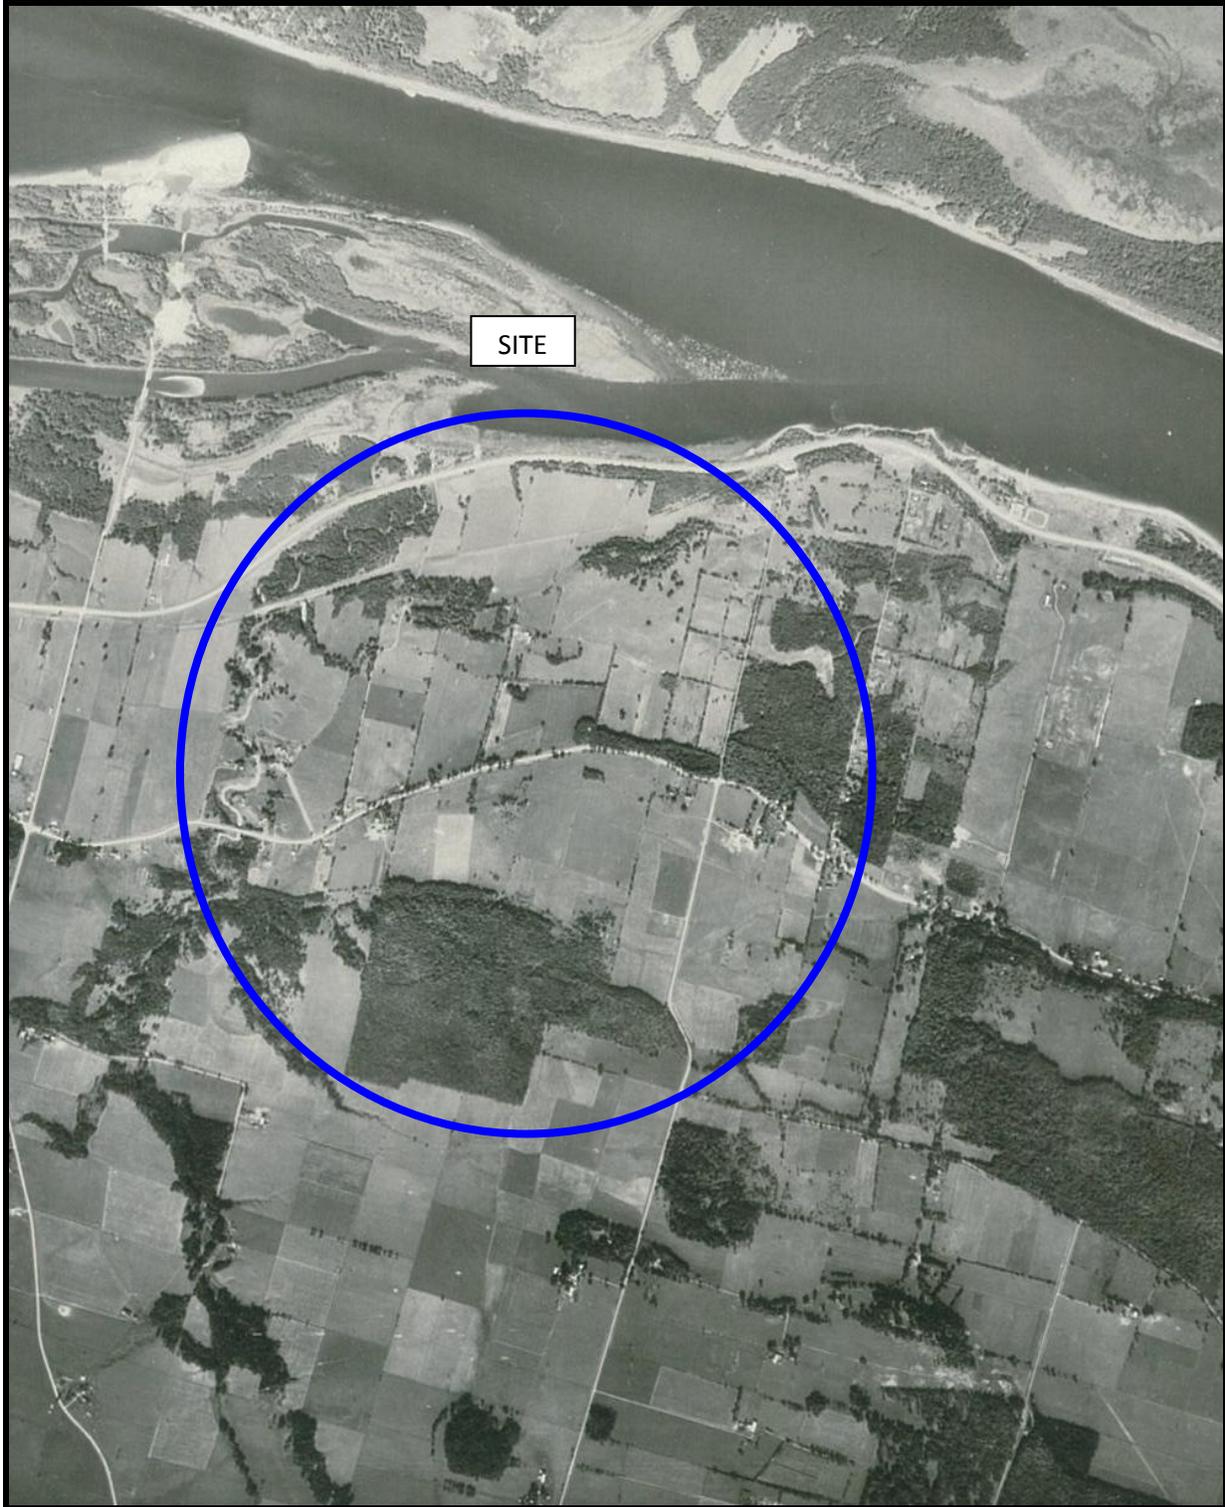
AERIAL PHOTOGRAPH  
1958

1958      No significant changes have been made to the subject site or surrounding properties.

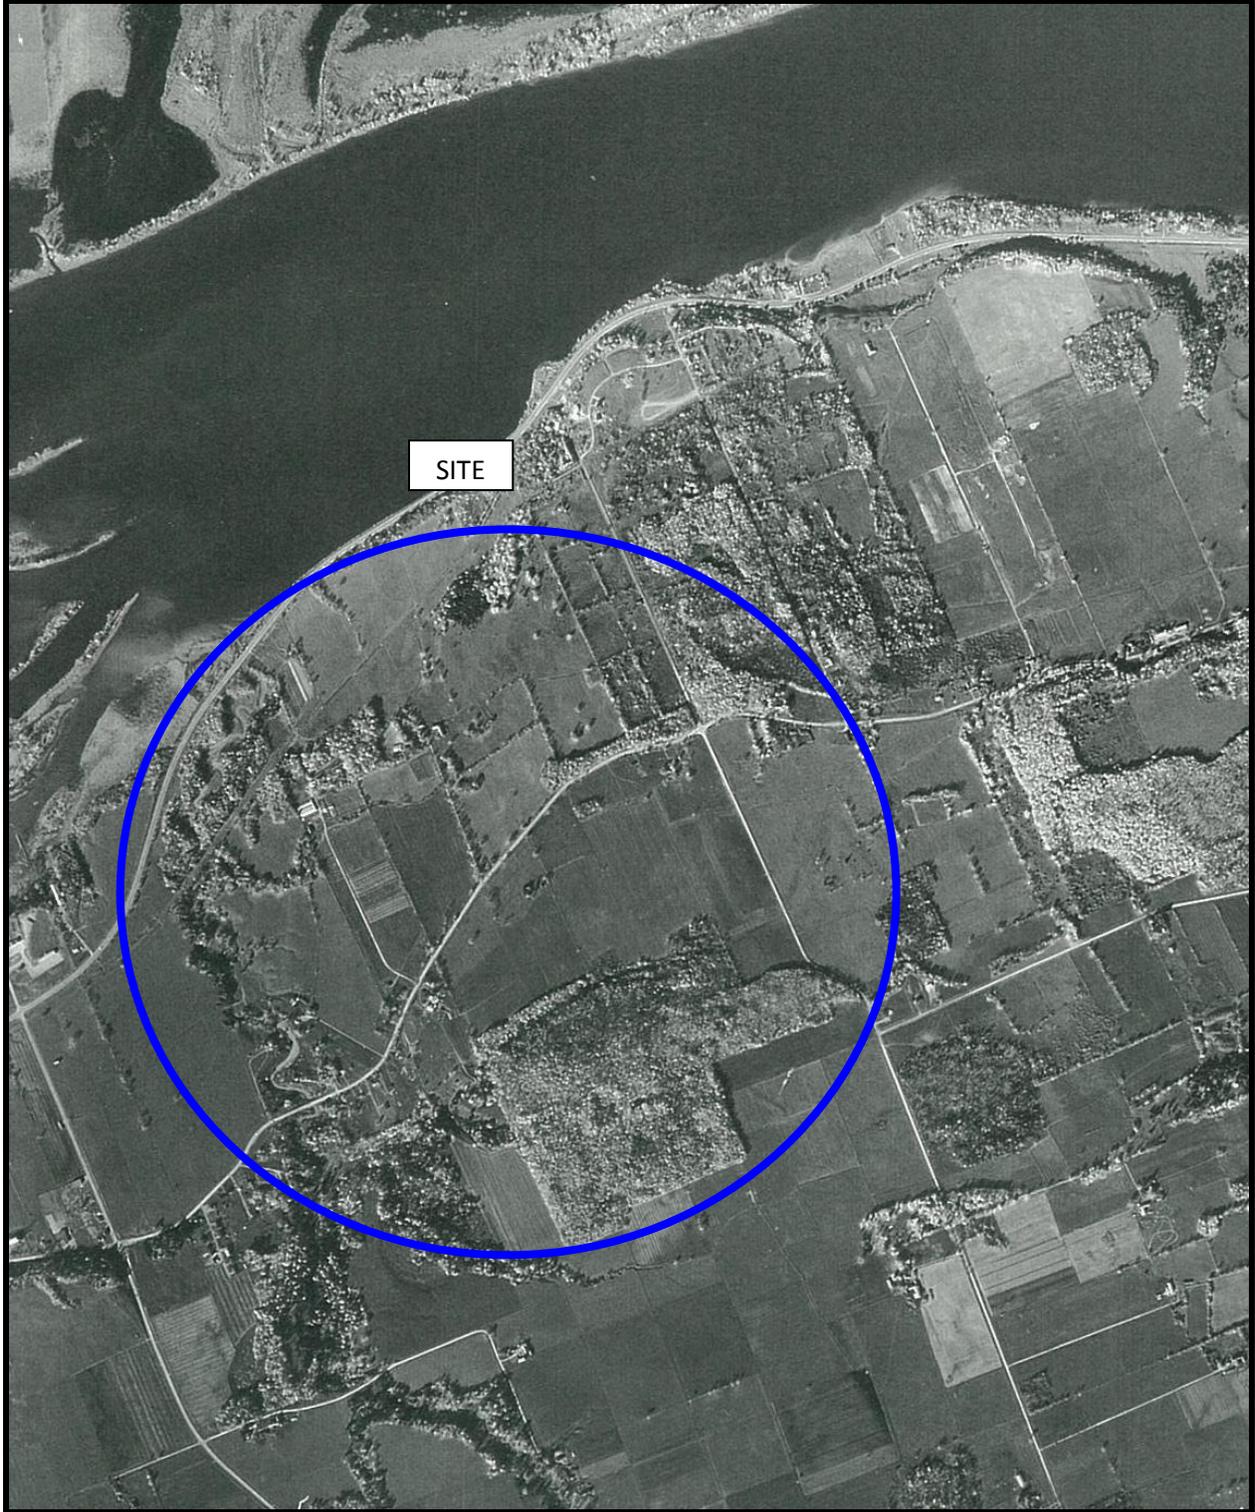
AERIAL PHOTOGRAPH  
1970

1970      The property to the west of 1291 Montreal Road appears to have been developed with the present-day greenhouse business. A laneway and possible residential structure is present north of the greenhouse business. Additional residences have been developed along the north and south sides of Old Montreal Road, on the western portion of the subject site. Grand-Chêne Court is present.

What appear to be residential dwellings are present east of Frank Kenney Road along Wilhaven Drive. Residential dwellings are also present along Old Montreal Road, west of the subject site and a possible farmstead is present west of the site, north of Regional Road 174. No other significant changes have been made to the subject site or surrounding properties.

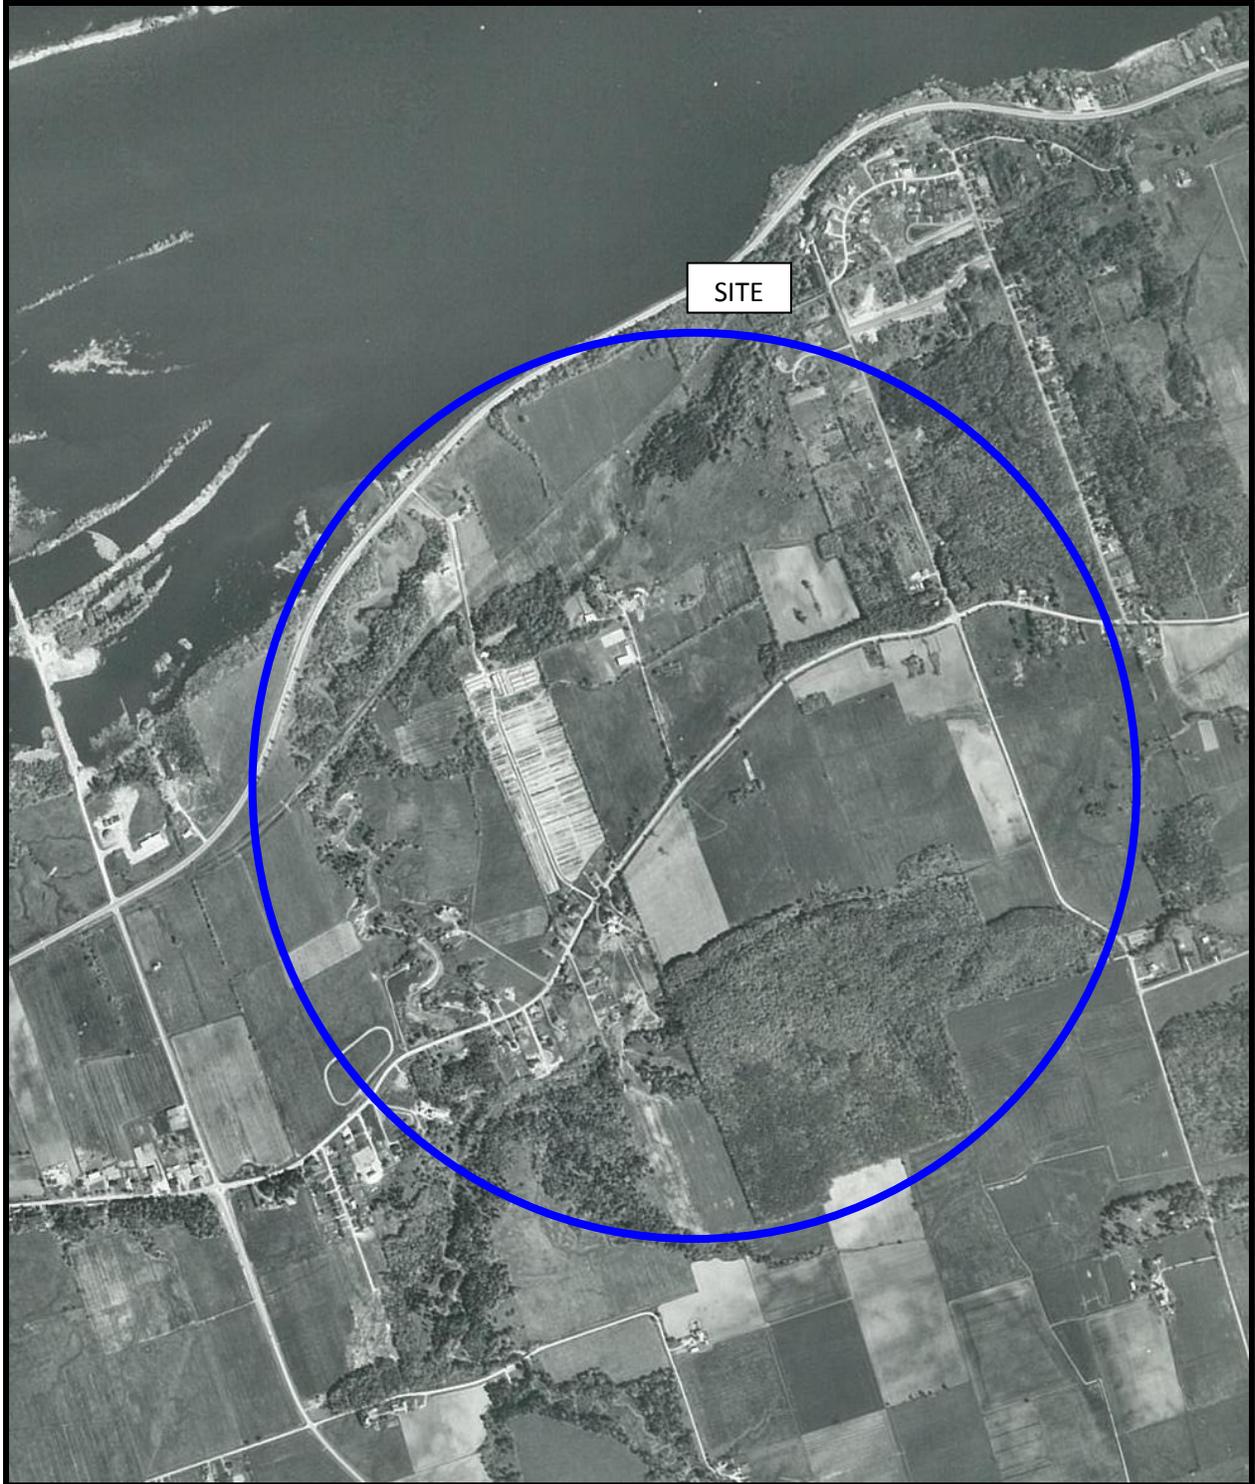
AERIAL PHOTOGRAPH  
1979

1979      The residential dwellings at 1172, 1176 and 1180 Old Montreal Road are present. Activity appears to have occurred on the southern portion of the property addressed 1208 Old Montreal Road and the property at 1222 Old Montreal Road may be under construction.

Additional residential development has occurred along Ted Kelly Lane. No other significant changes appear to have been made to the subject site or surrounding properties.

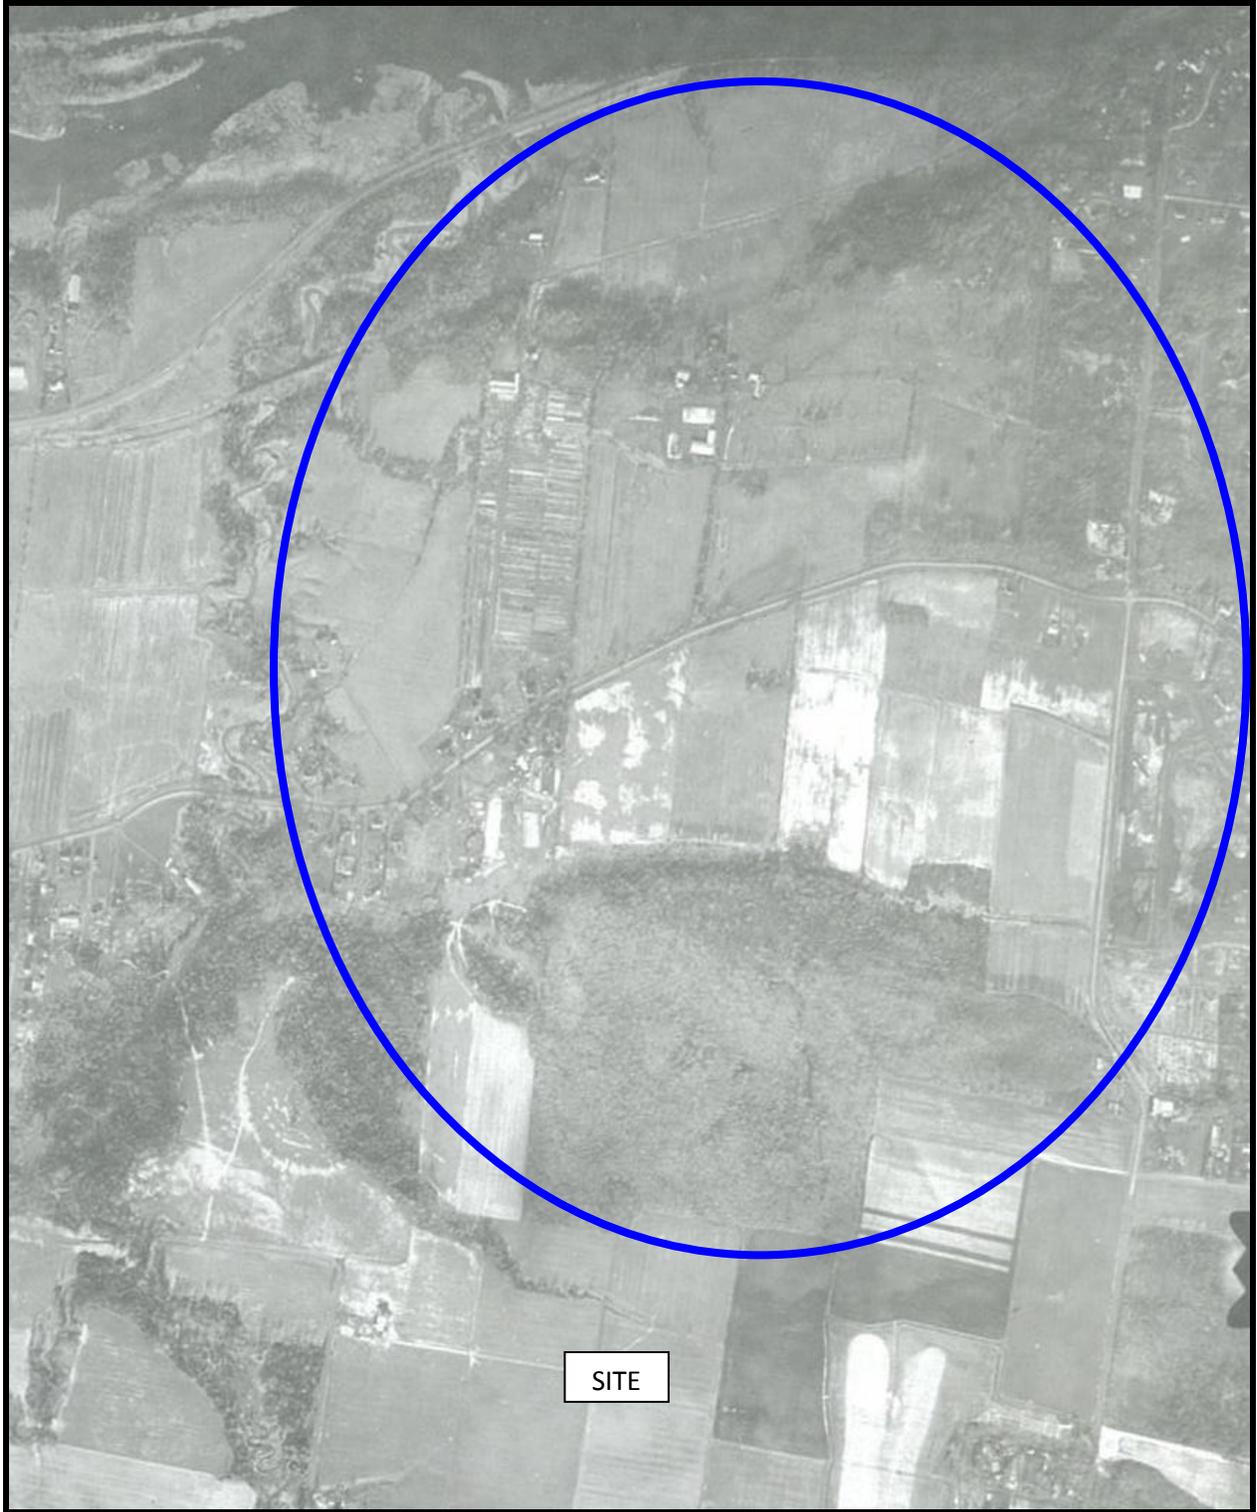
AERIAL PHOTOGRAPH  
1988

1988      (Poor Quality) No significant changes appear to have been made to the subject site or surrounding properties.

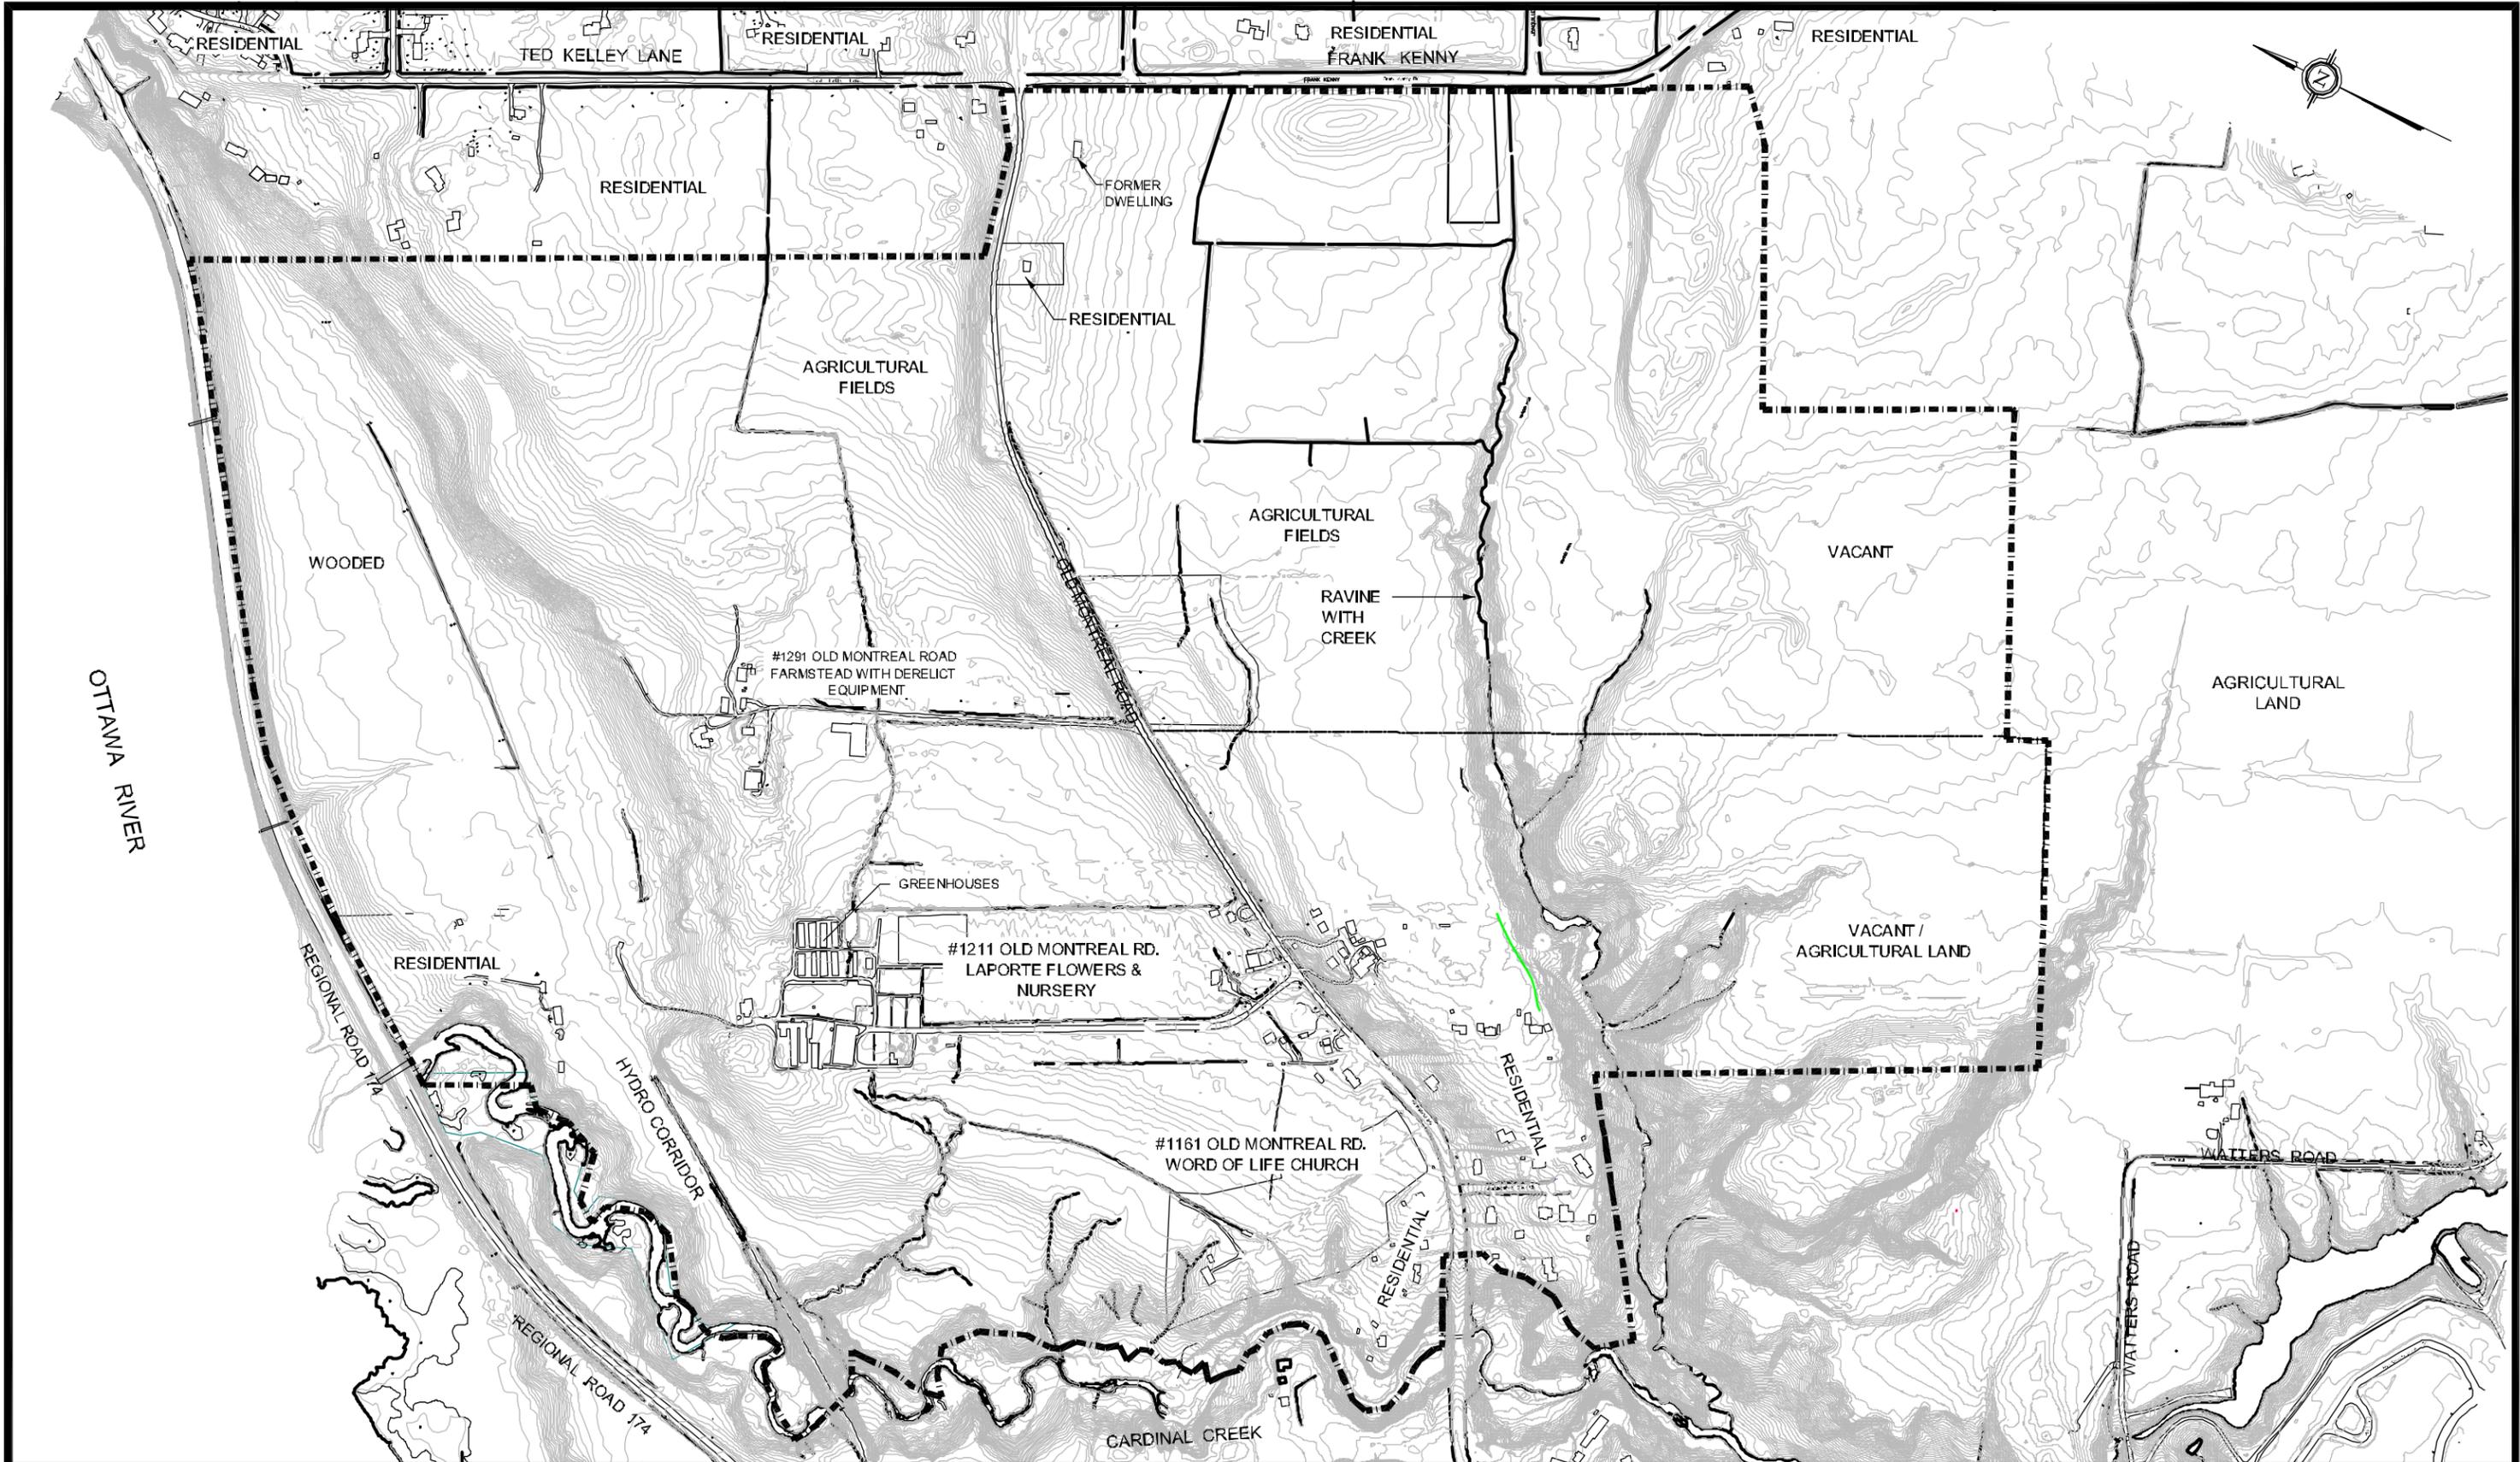
**SITE PLAN**

The current use of the immediately adjacent properties and neighbouring properties is not considered to pose a concern to the subject site. Current land use adjacent to the subject property is illustrated on Drawing No. PE2392- 2 - Site Plan appended to this report.
