Geotechnical Investigation

Proposed Cardinal Creek Village
Residential/Commercial Development
Old Montreal Road
Ottawa, Ontario

Tamarack Homes

Report PG1796-1R

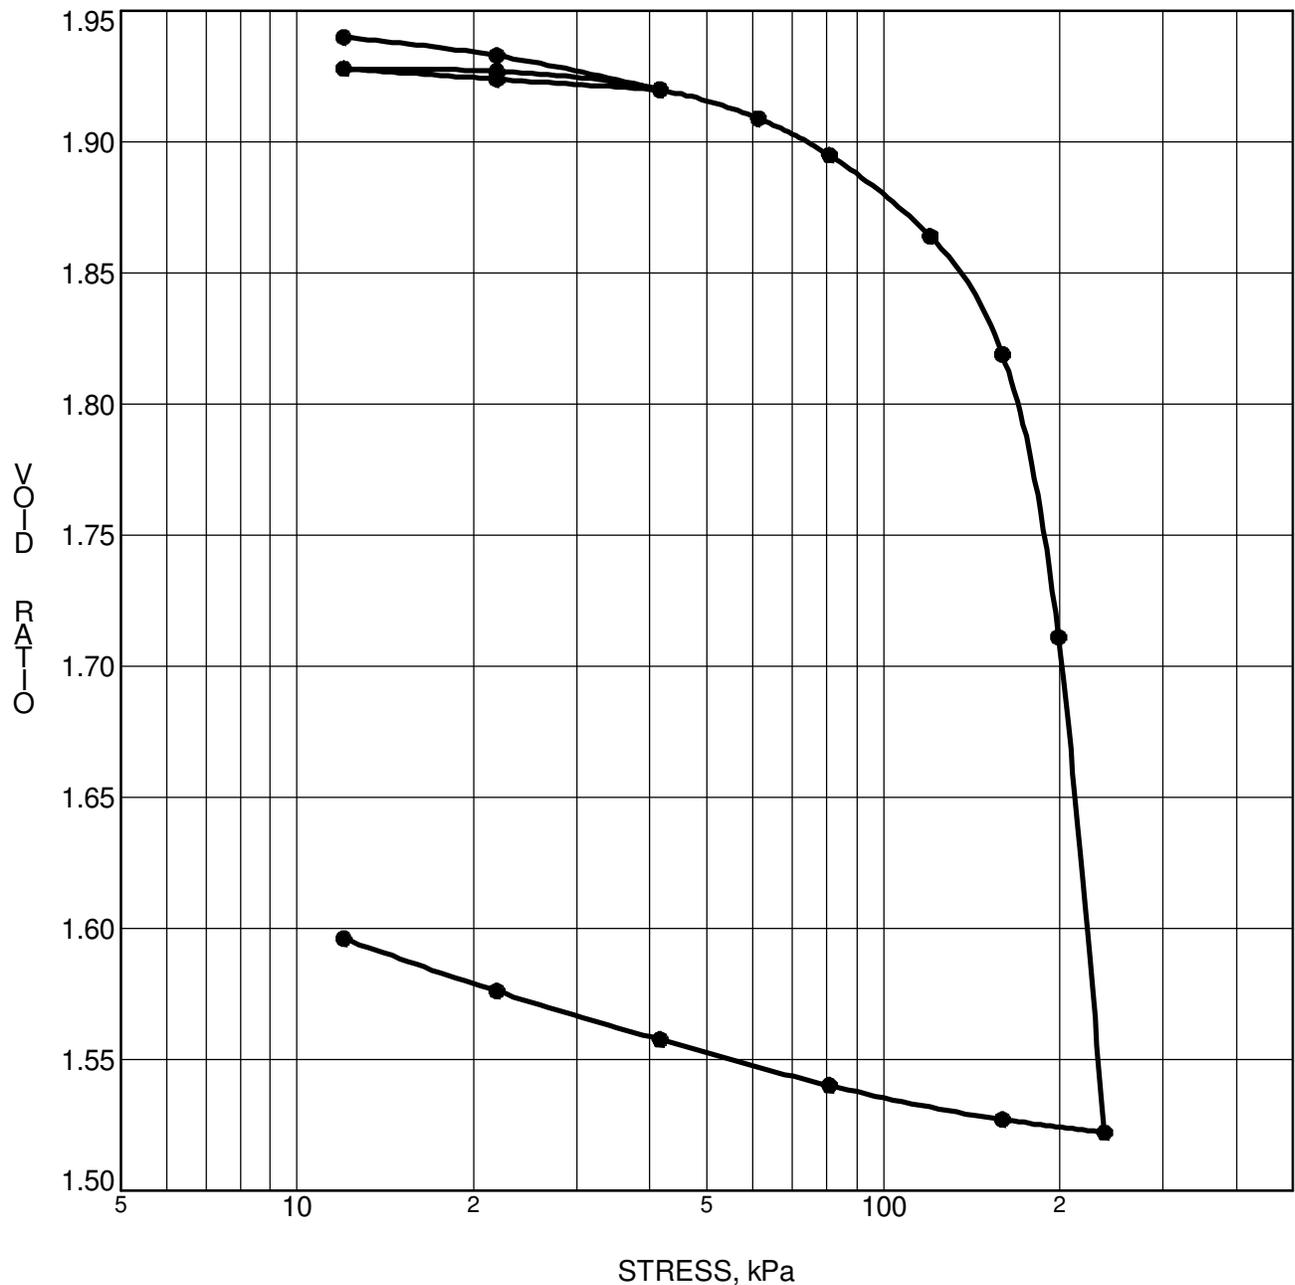
CONSOLIDATION TEST DATA SUMMARY					
Borehole No.	BH 4B	p'_o	64 kPa	C_{cr}	0.015
Sample No.	TW 1	p'_c	174 kPa	C_c	2.432
Sample Depth	4.19 m	OC Ratio	2.7	W_o	70.8 %
Sample Elev.	49.53 m	Void Ratio	1.948	Unit Wt.	15.9 kN/m³

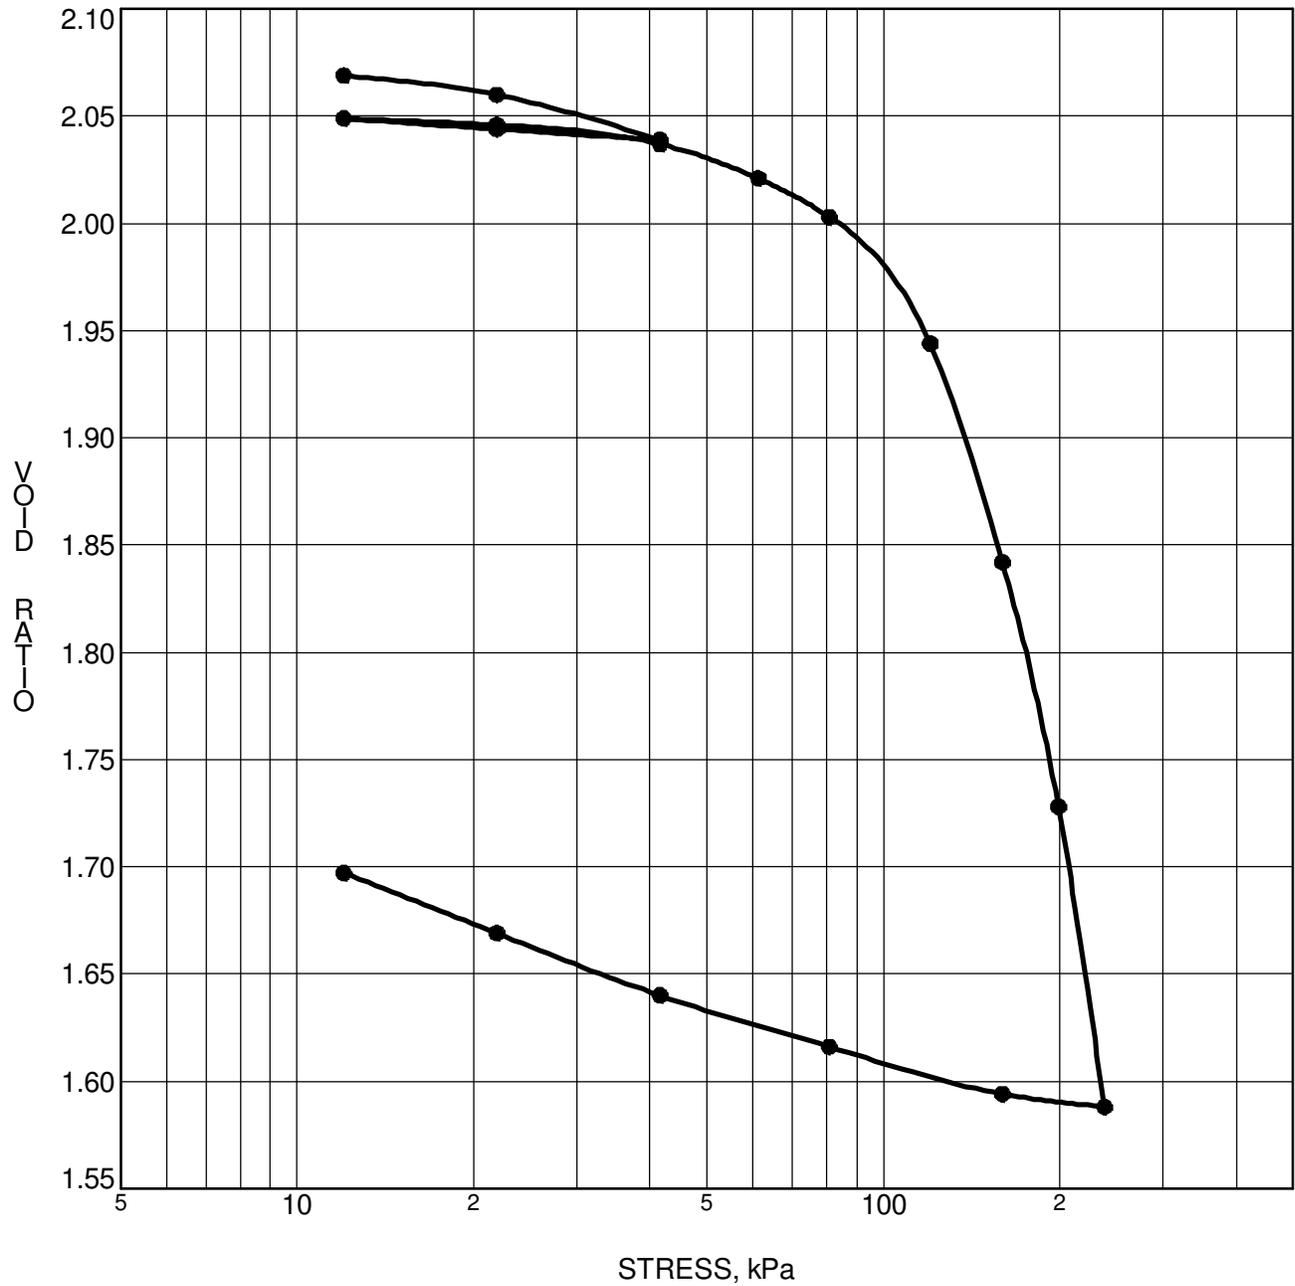
CONSOLIDATION TEST DATA SUMMARY					
Borehole No.	BH 5	p'_o	74 kPa	C_{cr}	0.021
Sample No.	TW 1	p'_c	147 kPa	C_c	1.863
Sample Depth	5.69 m	OC Ratio	2.0	W_o	75.7 %
Sample Elev.	47.59 m	Void Ratio	2.081	Unit Wt.	15.7 kN/m³

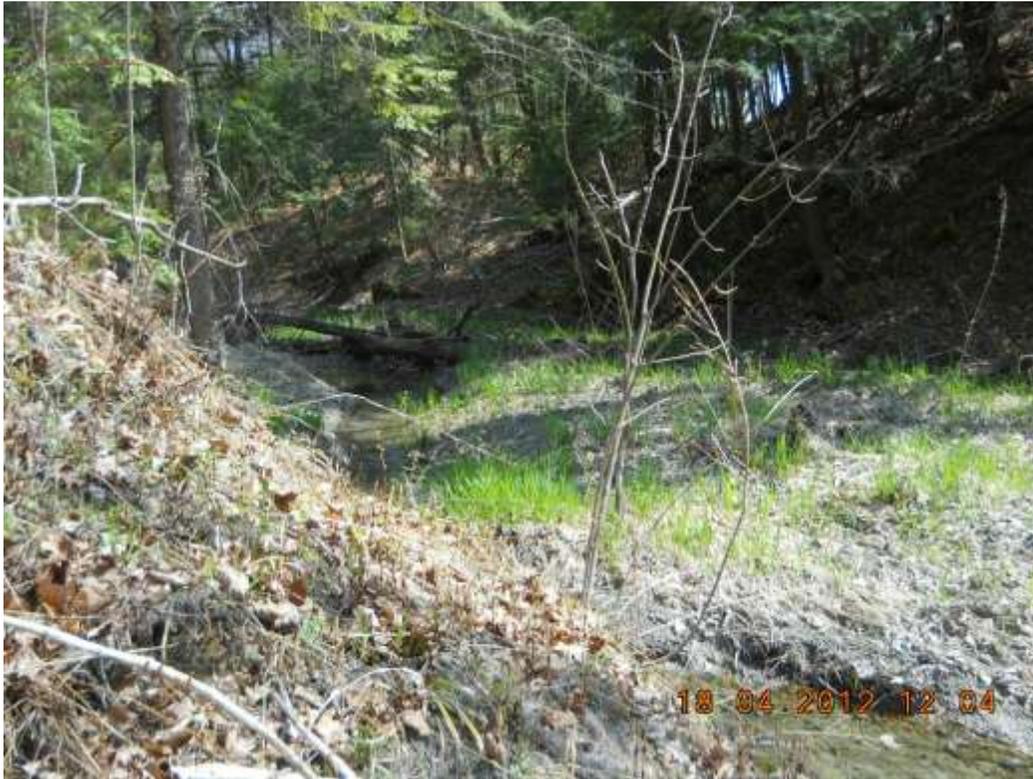
Photo 1: Photo taken on April 18, 2012 from the north bank of the valley corridor wall along Reach TRH2 looking east (upstream) near Section I.

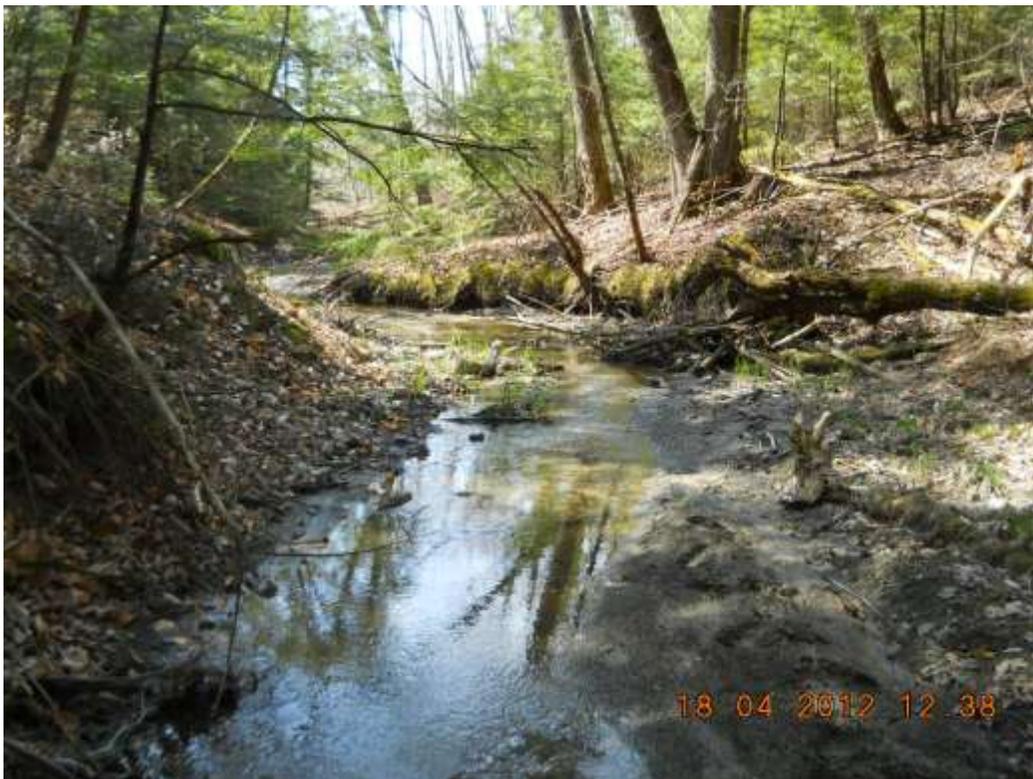
Photo 2: Photo taken on April 18, 2012 from the centre of the watercourse along Reach TRH1 looking west (downstream) near Section H.

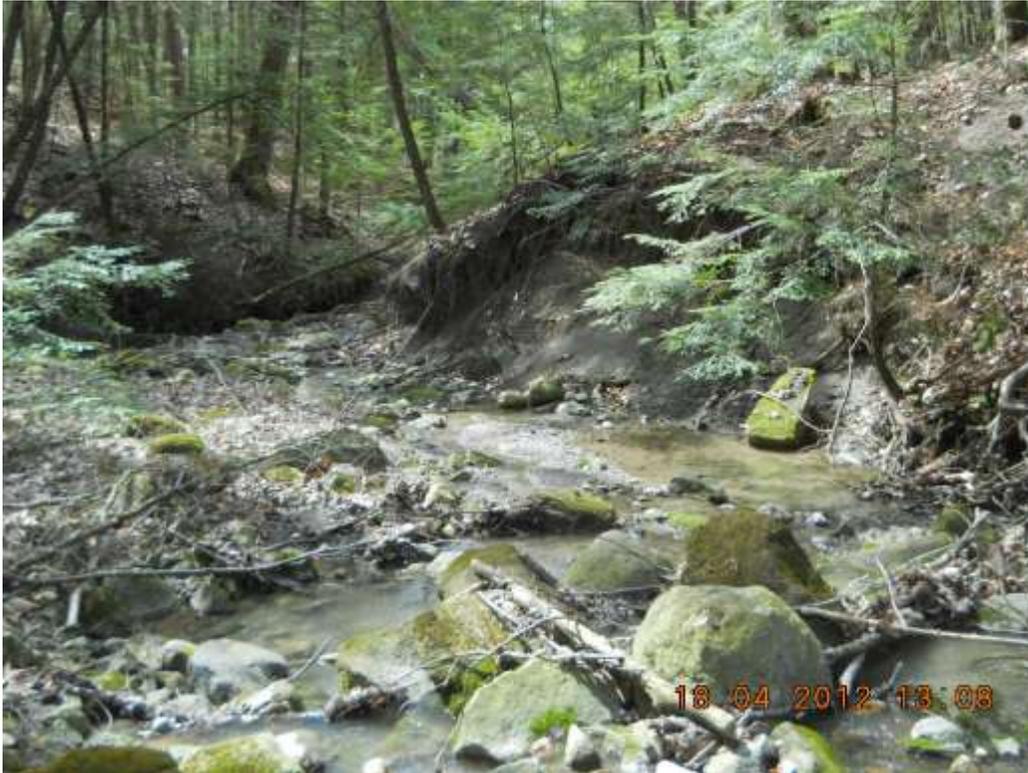
Photo 3: Photo taken on April 18, 2012 from the north bank of the valley corridor wall along Reach TRH1 looking west (downstream) at Section G.

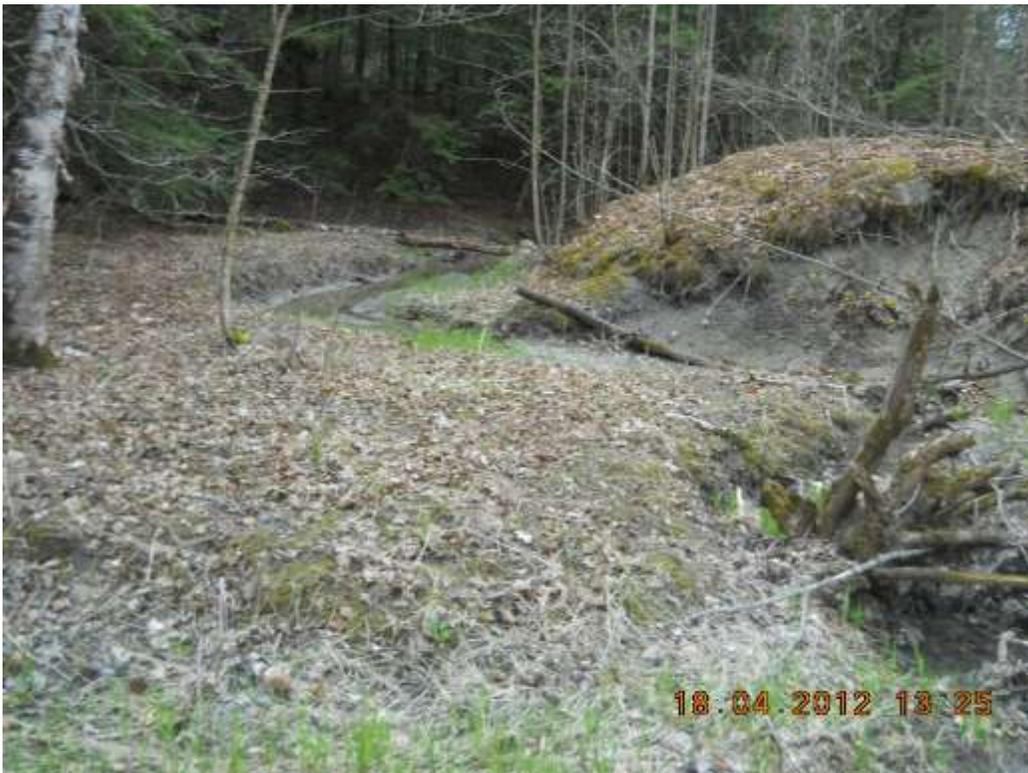
Photo 4: Photo taken on April 18, 2012 from the south bank of the valley corridor looking west (downstream) near Section F.

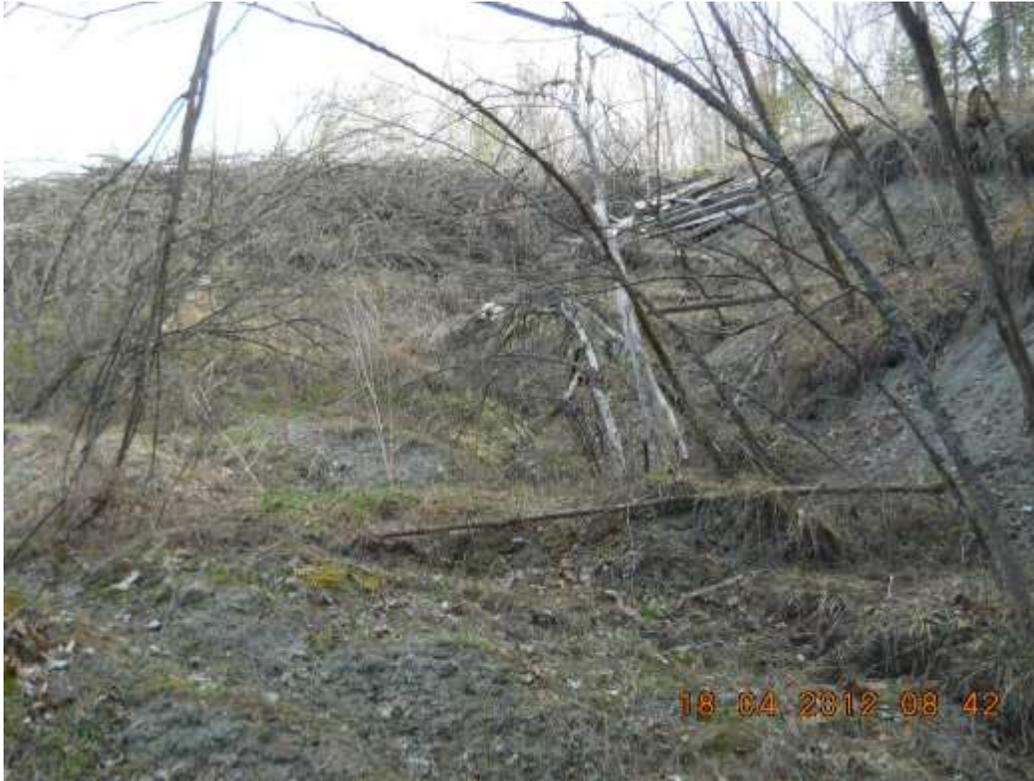
Photo 5: Photo taken on April 18, 2012 of the east bank of the valley corridor along Reach TRH2, north of Section J.

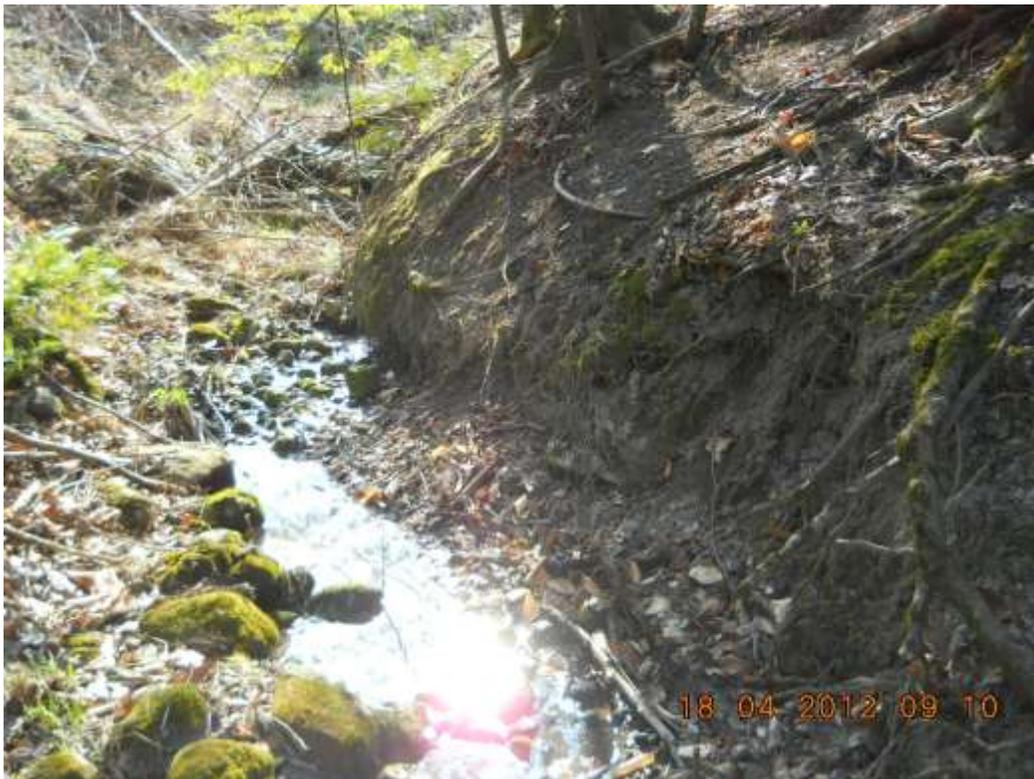
Photo 6: Photo taken on April 18, 2012 along the watercourse along Reach TRH4 looking east (upstream) near Section N.

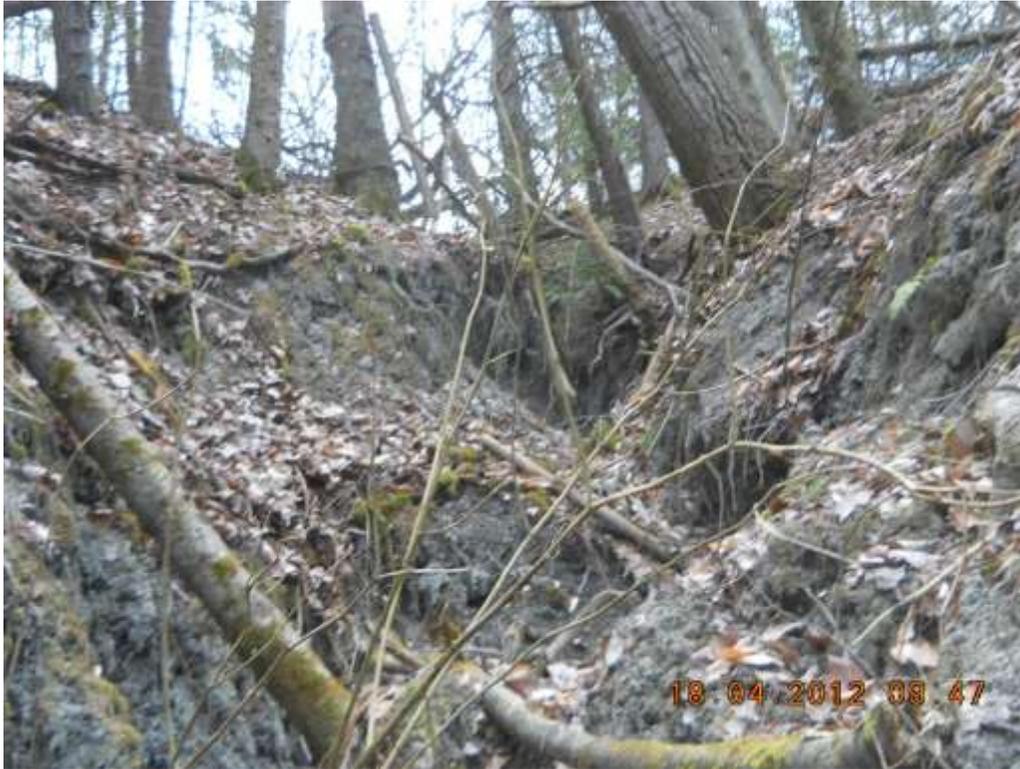
Photo 7: Photo taken on April 18, 2012 of the drainage ravine near Section K.

The majority of the tributary to the Cardinal Creek (Section TRH1, TRH2, TRH3, TRH4 and TRH5) were observed to be stable based on the slope condition review conducted on April 18, 2012 with some toe erosion noted throughout where the watercourse is located in close proximity to the valley corridor wall. Minor surface erosion was also noted along the east bank near Slope Cross-Section K (Section TRH5) illustrated in Photograph 7 in Appendix 2.

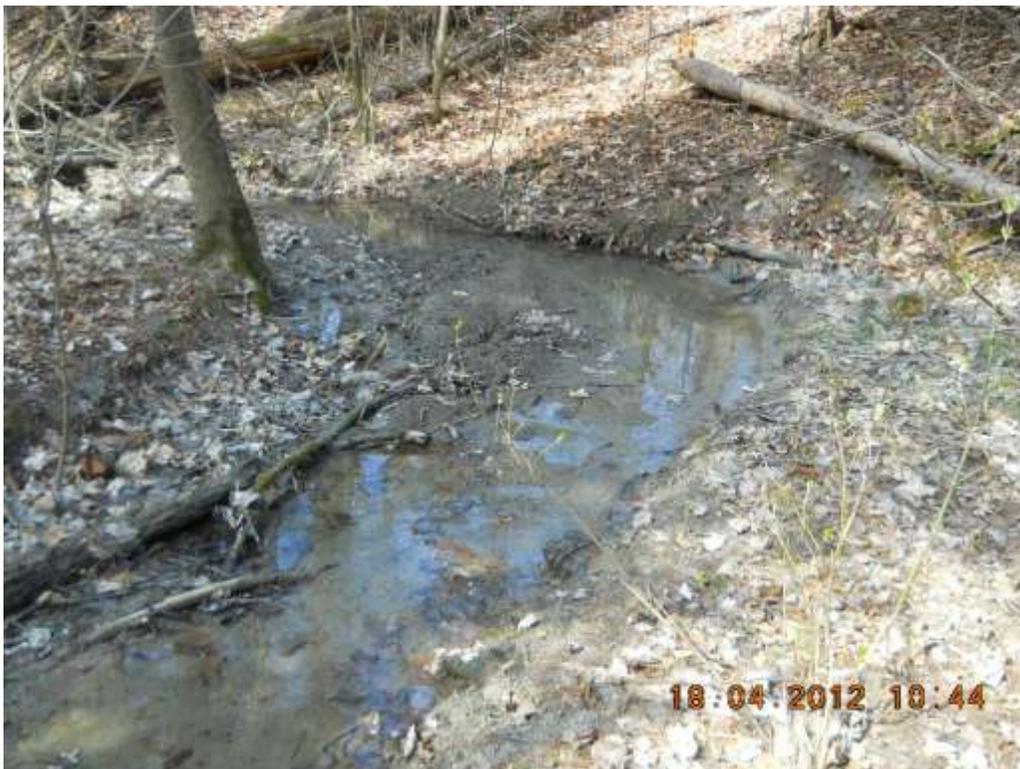
Photo 8: Photo taken on April 18, 2012 from the north bank of the valley corridor along Reach TRH 5 looking west (downstream) near Section M.

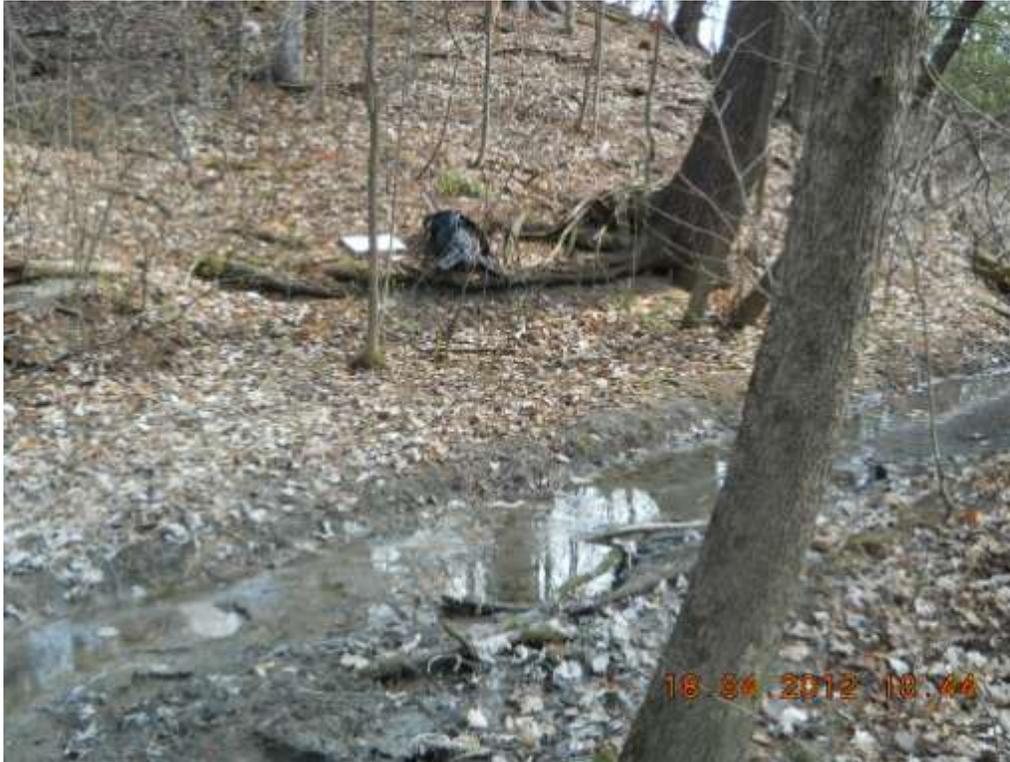
Photo 9: Photo taken on April 18, 2012 from the south bank of the valley corridor wall along Reach TRH5 looking east (upstream) near Section M.

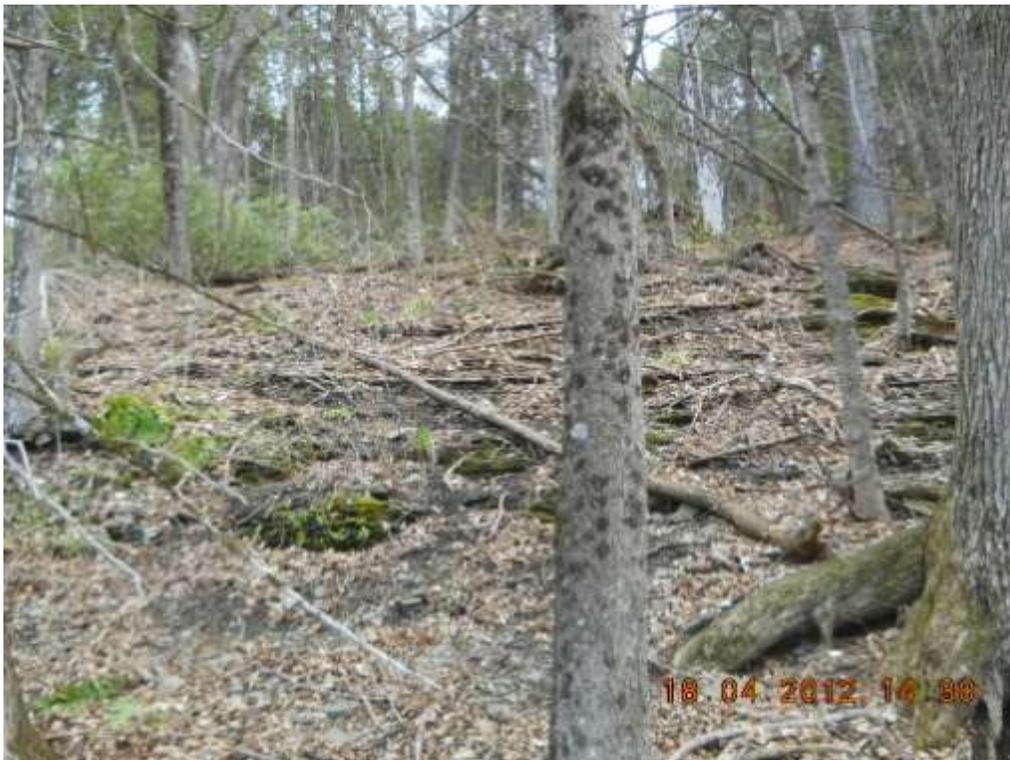
Photo 10: Photo taken of bedrock outcrop at Section D.

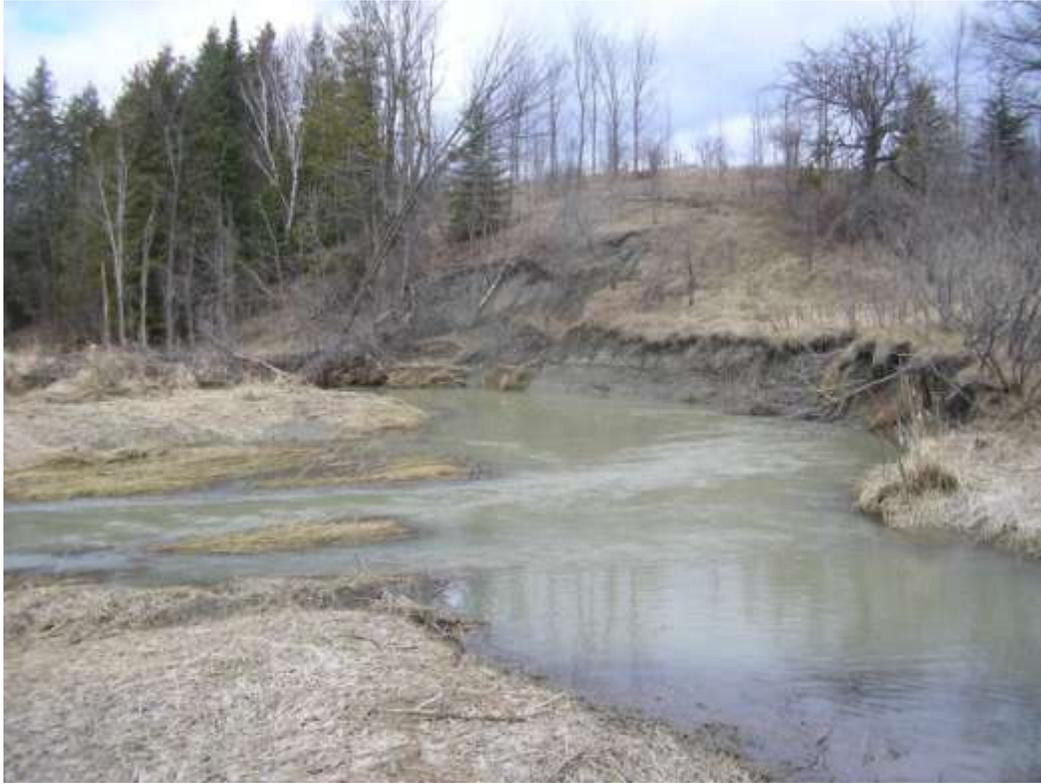
Photo 11: Photo taken on April 9, 2009 from the east bank of the valley corridor wall along Reach C11 looking north (downstream) near Section C.

Photograph 11 and Photograph 12 taken during the initial slope condition review on April 9, 2009 presented in Appendix 2 illustrates where the Cardinal Creek (C11) has meandering in close proximity of the valley corridor wall causing erosion and exposing the clay surface from consequent slip failures. Photograph 13 and Photograph 14 taken from the north banks of the Cardinal Creek (Section C12) on April 9, 2009 illustrates the water cresting over the meandering watercourse and covering the valley corridor from the mouth of the Cardinal Creek to the former Rail Line. It is noted that the subject section of watercourse is considered stable to moderately stable. However, it is recommended that a monitoring program be initiated and a possible toe erosion protection program for areas where the watercourse is in close proximity of the valley walls, primarily along Reach C11.

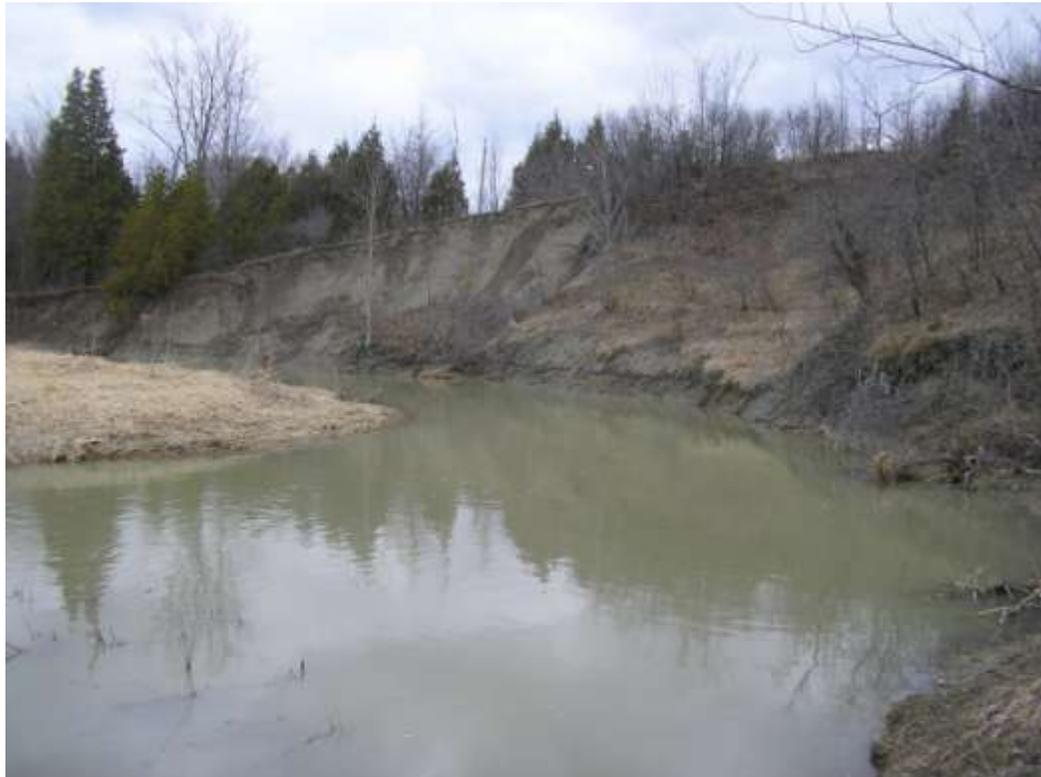
Photo 12: Photo taken on April 9, 2009 from the east bank of the valley corridor wall along Reach C11 looking north (downstream) approximately 150 m south of the former Rail Line.

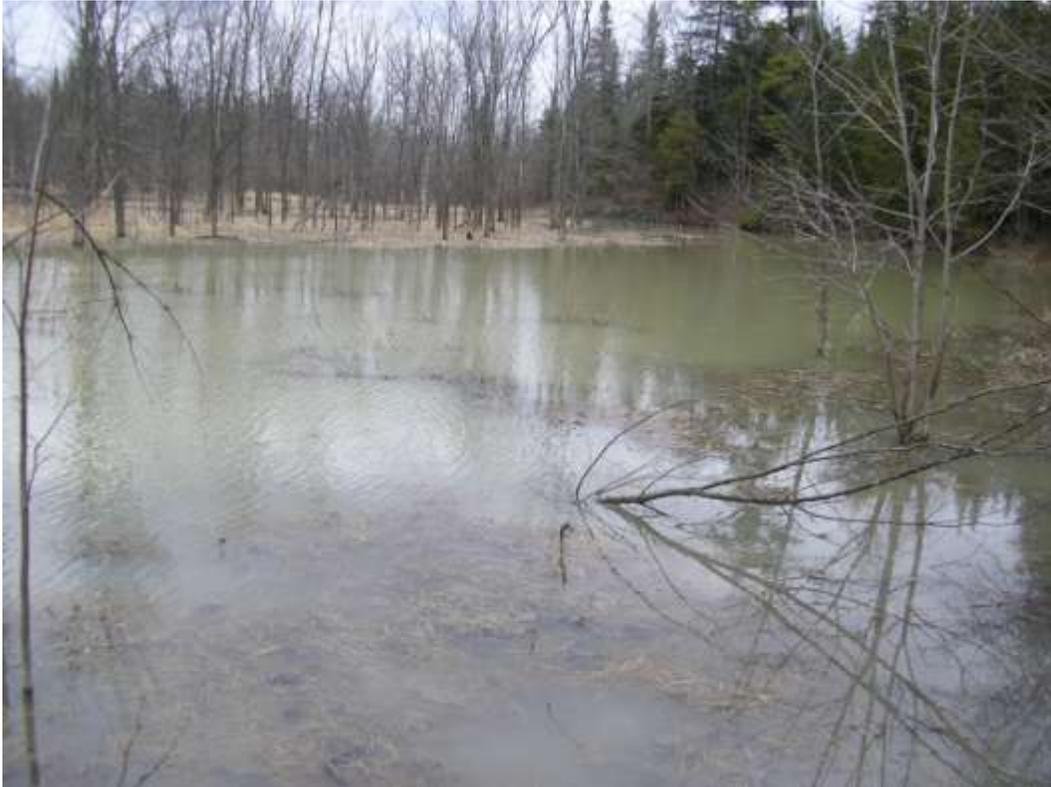
Photo 13: Photo taken on April 9, 2009 from the east bank of the valley corridor along Reach C12 looking north (downstream) near Section B.

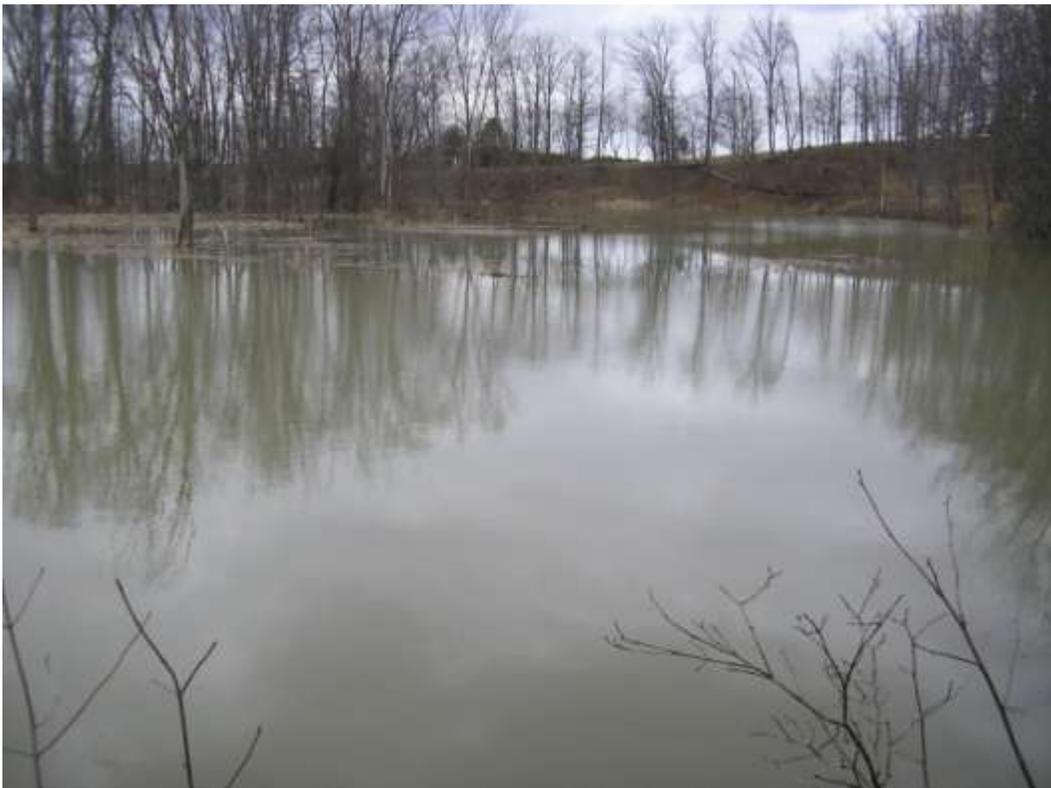
Photo 14: Photo taken on April 9, 2009 from the east bank of the valley corridor wall along Reach C12 looking north (downstream) near Section A.

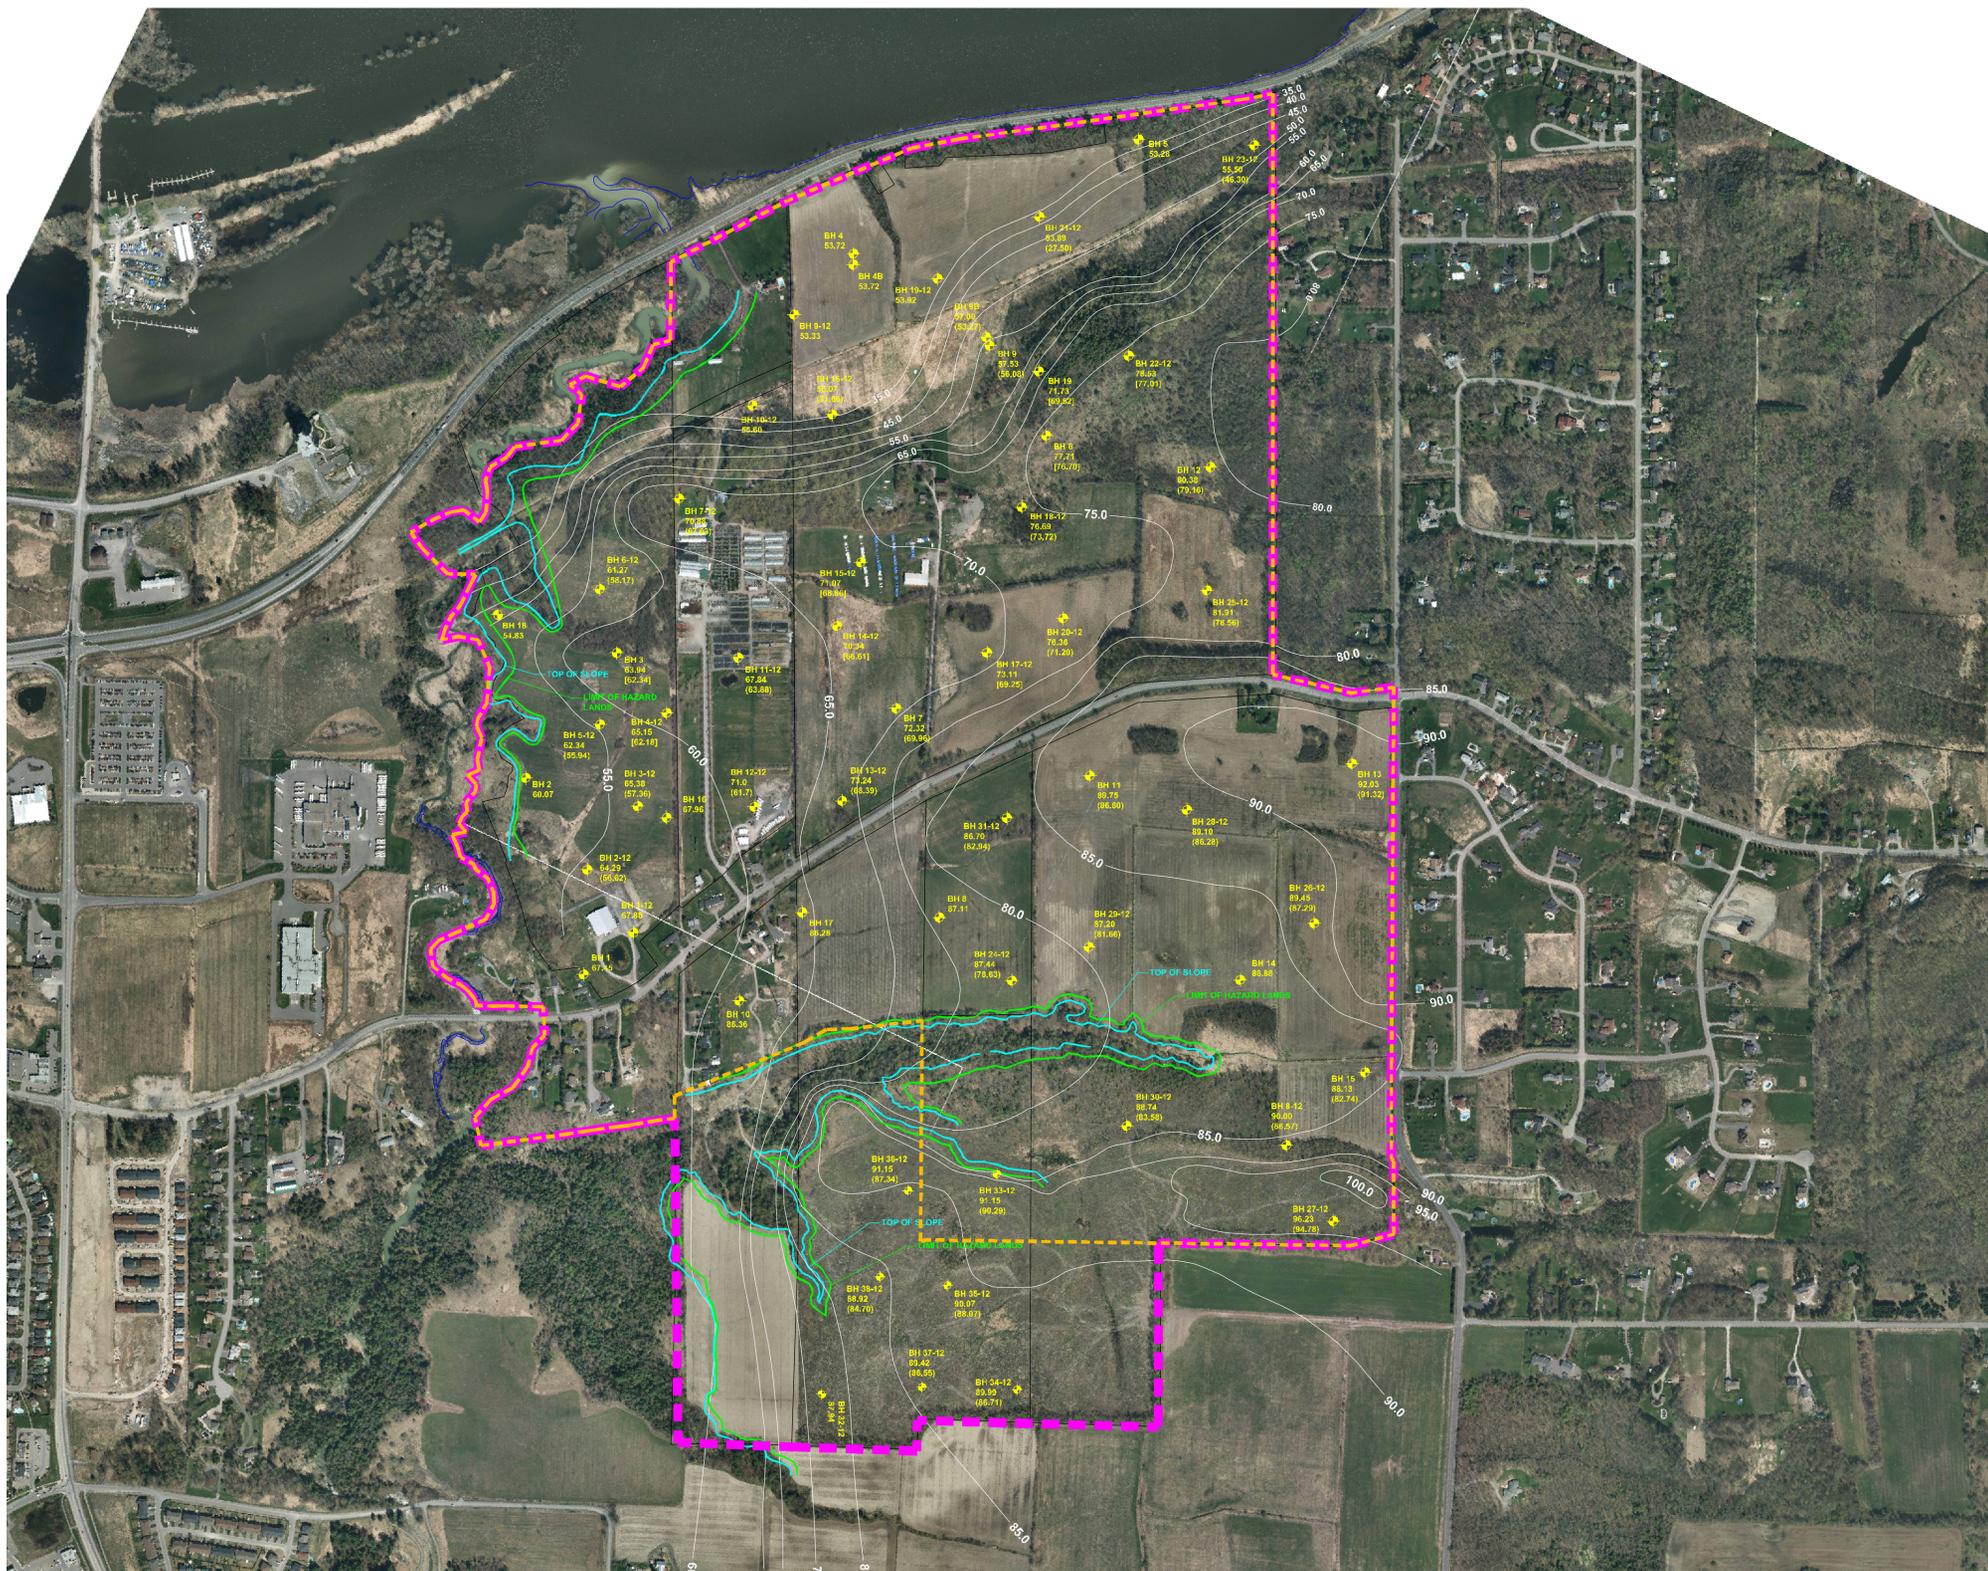
GEOTECHNICAL INVESTIGATION
CARDINAL CREEK VILLAGE
OTTAWA, ONTARIO
 DWG. NO. PG1796-3

TAMARACK HOMES
TEST HOLE LOCATION PLAN
